# Infralog

## CFS Infrastructure and Logistics Update:

### Issue 33 - March 2013

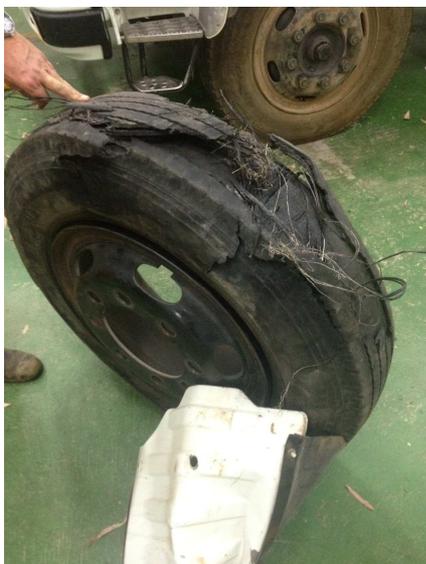
The photo on the left shows a tyre off a CFS appliance that almost certainly failed due to age. Indications are that the tyre was eighteen years old. Fortunately the driver managed to control the vehicle when the tyre failed and bring it safe to a stop. The consequences had he failed to do so could have been catastrophic. The brigade reported the incident and in doing so highlighted the risk we are

As a result of incidents we are aware of including one in Region 6 several years ago, one in Region 1 last year and this incident Brigades are instructed to inspect the tyres on their appliances to ascertain their age. This is achieved by looking for the Tyre Identification Number (or serial TIN) that shows the date of manufacture of a tyre. The TIN is located on the sidewall of the tyre and is normally found adjacent to the flange of the rim. The last three

digits of the TIN for tyres made pre 2000, (e.g. “128” denoted the 12th week of 1998 or 1988) or the last four digits for tyres made post 2000, (e.g. “1207” denotes the 12th week of 2007) shows when the tyre was manufactured.

When tyres on the front axle, namely steer tyres, are identified as being ten years or older they should be replaced immediately as they pose an unacceptable risk to those operating the appliance. The remaining tyres on the vehicle, including the spare, that are identified as being ten years or older should also be replaced at the first opportunity irrespective of how much tread remains. These tyres pose less of a risk due to the dual rear tyre configuration used on CFS appliances.

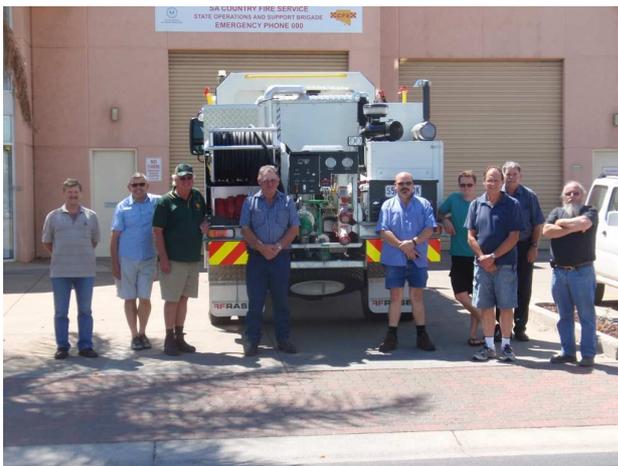
The Prototype 34 with rearward facing 60m hose reel and twin “dead” reels was displayed and comments sought. The feedback received was extremely positive and it was agreed that the opportunity should be taken to display the appliance as widely as possible. A decision has to be made by the end of March as to whether this design will be produced next financial year or the current two hose reel design.

One appliance already delivered is the prototype 34 which has an east-west pump, a rearward facing 60m live hose reel and 2 dead hose reels. The intent is to display this vehicle as widely as possible before it is delivered to its host Brigade.

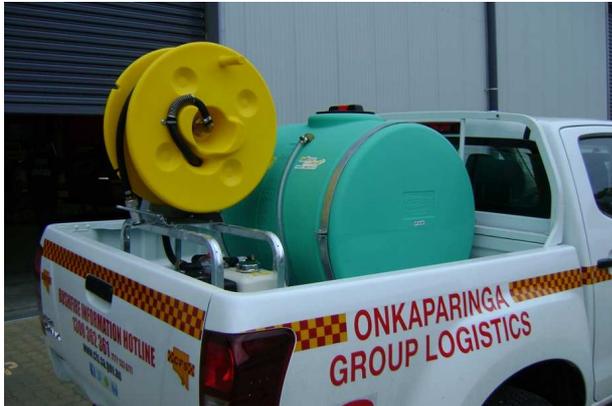
One Group, Onkaparinga Group, elected not to have a canopy fitted to their vehicle and instead chose to have a 'prototype slip-on' firefighting unit fitted. This has only just arrived and is shown placed in position. Work is currently being undertaken to mount it to the tray.

The unit is fitted with a 400 litre rotomoulded tank filled with baffle balls. The pump is a 2" Aussie Chief coupled to a petrol Honda GX160 Motor. The pump is fitted low on the tray to stop flame

impingement. A lightweight hose reel with 36m of 19mm hose is fitted above tray top level for ease of access. CFS will likely look at other hose reel options due to the height of the reel above the body. The dry weight of the unit as it currently stands is around 95kg.

The cost of this concept vehicle is less than half the price of the current Quick Response vehicles that we currently purchase. Work is required to see if this concept is functionally and operationally viable.
